BIOLOGICAL ASSESSMENT SURVEYS OF SELECTED LOCATIONS IN SANTIAGO CREEK - 2025

PREPARED FOR FRIENDS OF HARBORS, BEACHES, AND PARKS

SANTA ANA WATERSHED ASSOCIATION

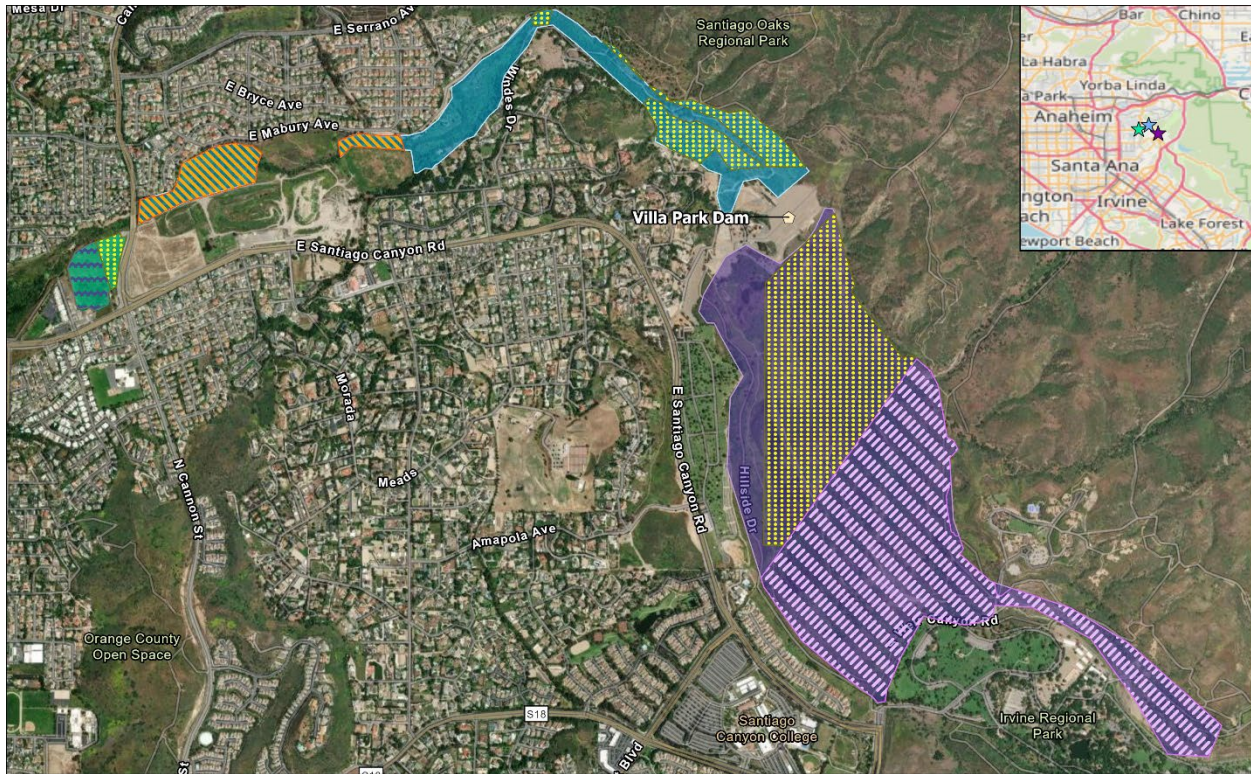
FIGURE 2: BIOLOGICAL ASSESSMENT SURVEY AREAS AND SELECT PROPERTY BOUNDARIES AT SANTIAGO CREEK, 2025

Seven locations along Santiago Creek were selected for biological assessment surveys. In upstream to downstream order these are: Section 1, Section 2, Section 3, Upstream Chapman, Chapman to 55, Cambridge to Hart Park, and I-5 to Flower (Figure 1). Section 1 includes parts of Irvine Regional Park, Santiago Oaks Regional Park, and additional parcels under various ownership. Section 2 includes parts of Santiago Oaks Regional Park and other parcels; part of this section is privately owned. Section 3 includes a small segment of Santiago Oaks Regional Park in addition to the Hurwitz property. These locations downstream of the Irvine Lake Dam were selected by SAWA and FHBP as separate locations that had riparian habitat potentially appropriate for sensitive species occupancy. The survey areas are separated into locations that have differing park names, land management or ownership (Figure 2).

Biological Assessment Survey Areas and Select Property Boundaries at Santiago Creek, 2025

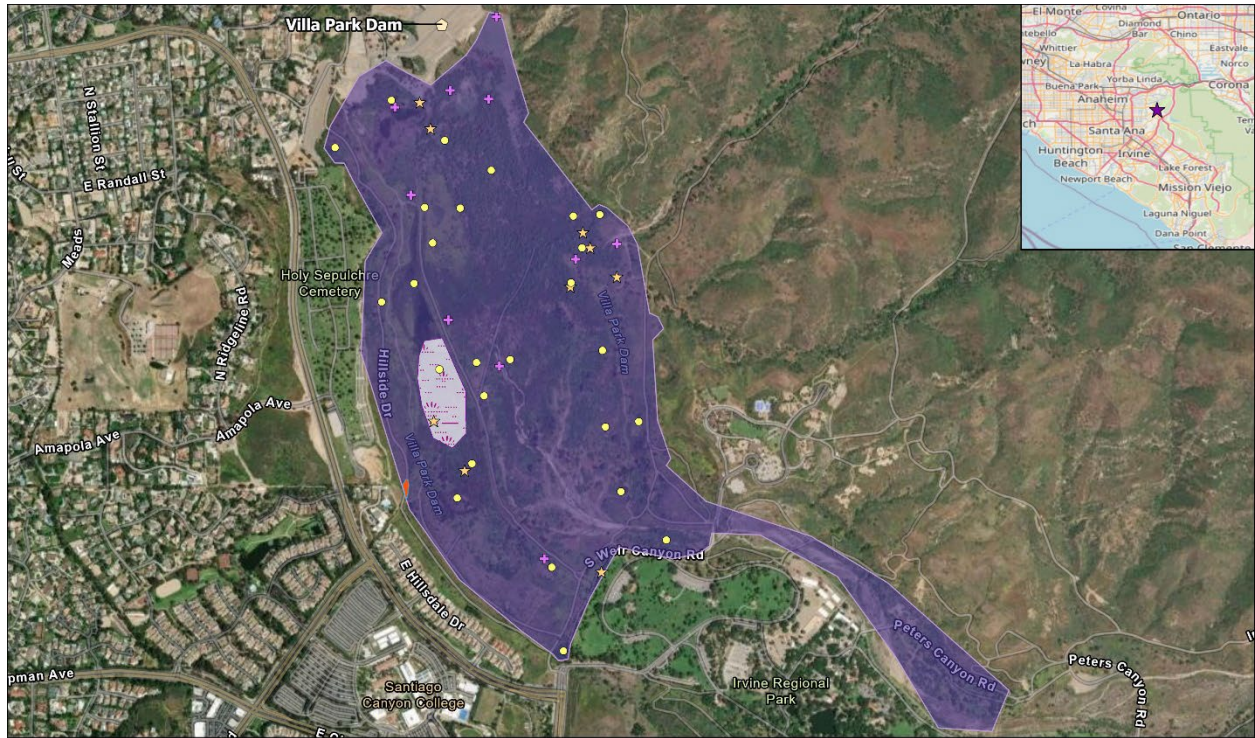
Survey Area and Special Status Species Detected at Santiago Creek - Section 1, 2025

The biological assessment took place on July 3, 2025. Two additional vireo assessment visits were conducted under a different funding source on April 22 and May 28, 2025. A large diversity of native vegetation and avian species are present. Twenty-six vireo territories were documented. Other special status species territories detected on site were ten Yellow-breasted Chat and nine Yellow Warbler, both of which are CDFW Species of Special Concern (CNDDDB, 2025). Vegetation coverage estimations for Santiago Creek – Section 1 are shown in Table 1.

This site is a passive park, but the riparian area is mostly avoided by the public. Threats to biological resources include risk of inundation from the Villa Park Dam water retention and potential wildfire risk.

The entire west portion of the site would benefit from tamarisk (*Tamarix ramosissima*) removal; patches of milk thistle (*Silybum marianum*) near the dam and in dried ponding areas should be targeted as well. There was a trace amount of stinknet (*Oncosiphon pilulifer*) found on one of the trails that should be addressed as soon as possible. Due to the presence of so many endangered birds at this location, restoration activities should be conducted outside of nesting bird season unless a permitted vireo biologist is present.

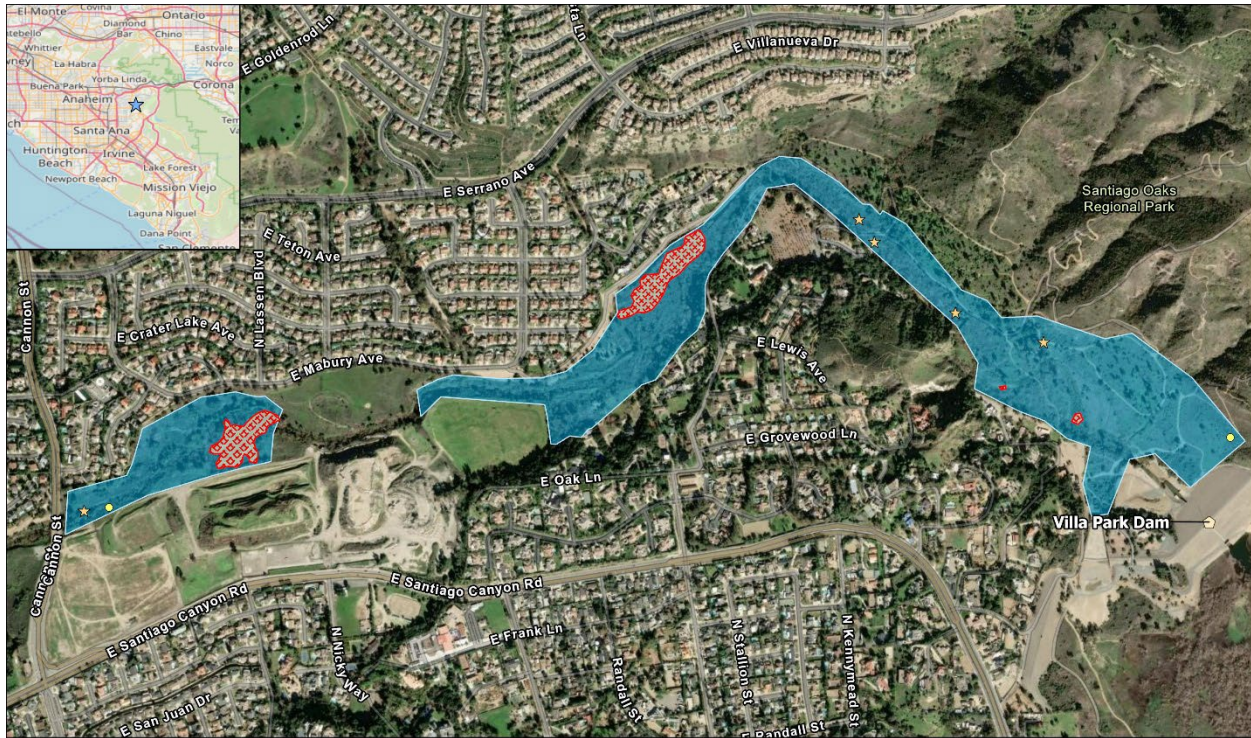
Survey Area and Special Status Species Detected at Santiago Creek - Section 2, 2025

The biological assessment took place on June 20, 2025. Weather during the bioassessment was overcast and cool, which could reduce the amount of avian and reptile species detected. Two additional vireo assessment visits were conducted under a different funding source on May 13 and July 15, 2025. A large diversity of native vegetation and avian species are present on site. Two vireo territories were documented. The other special-status species detected on site was Yellow Warbler. Although no Yellow-breasted Chats were observed at this site in 2025, SAWA biologists observed three territories in 2024 and 10 territories at Santiago Creek – Section 1, immediately upstream from this site, in 2025. Vegetation coverage estimations for Santiago Creek - Section 2 are shown in Table 2.

This site is a passive park, but the riparian area is mostly protected. Threats to biological resources include risk of flood damage from Villa Park Dam water releases and potential for wildfire.

Active restoration is occurring in the park, but the downstream section of the site has additional restoration needs. Removal of Mexican fan palms (*Washingtonia robusta*) and large patches of giant reed (*Arundo donax*; hereafter “arundo”) is recommended. Due to the presence of an endangered bird at this site, restoration activities should be conducted outside of nesting bird season unless a permitted vireo biologist is present.

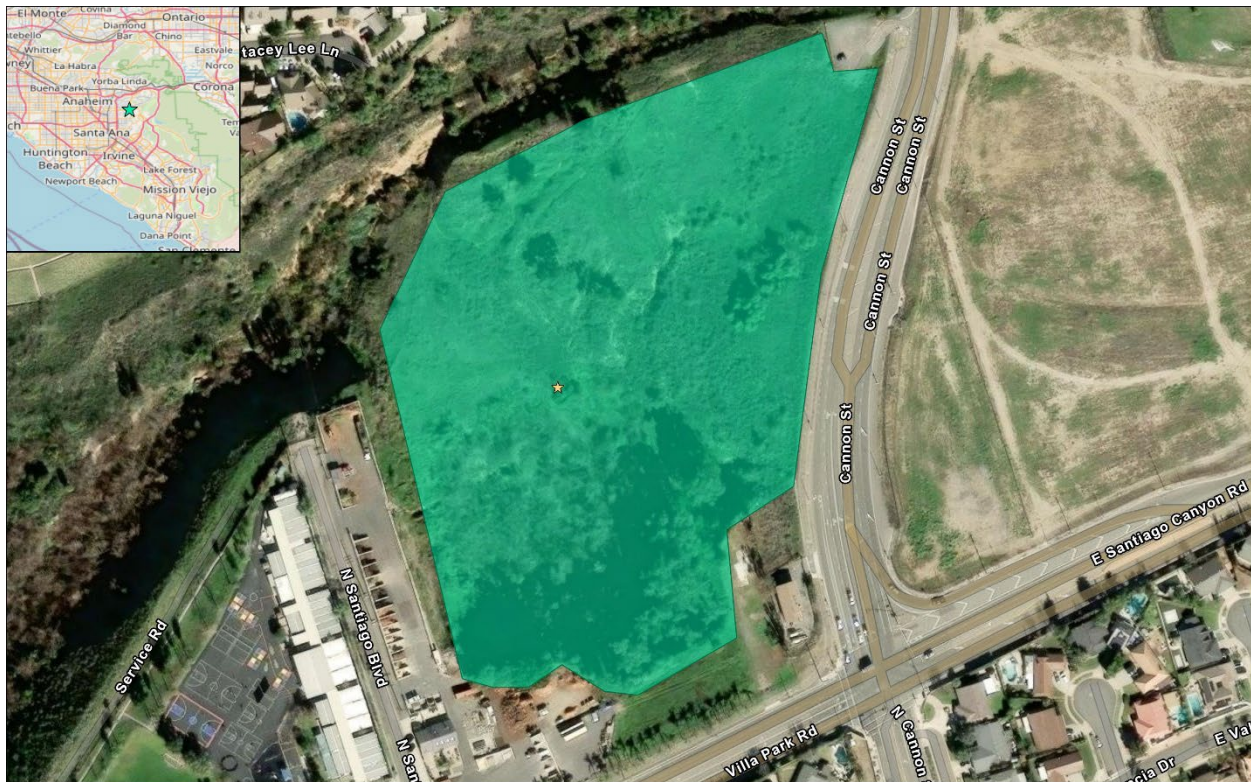
Survey Area and Special Status Species Detected at Santiago Creek - Section 3, 2025

The biological assessment took place on June 12, 2025. The site contains both riparian and CSS habitat. No vireo territories were documented; however, one territory was present in 2024, and the site contains suitable vireo habitat. No California Gnatcatcher, a federally threatened and CDFW Species of Special Concern (CNDDDB, 2025), were found on site in 2025, but one territory was detected in the adjacent Smith Basin in 2024, so the species could be present. One Yellow Warbler was detected. Vegetation coverage estimations for Section 3 are shown in Table 3.

Restoration opportunities in the riparian habitat include removal of invasive plant species including hemlock (*Conium maculatum*), tamarisk, and castor bean (*Ricinus communis*). The addition of mulefat pole-cuttings, which may not need to be irrigated at this site, is also recommended. The coastal sage scrub portion of the site would benefit from removal of invasive plant species (mustard species, *Brassica* spp., and castor bean) and planting of additional CSS species such as black or white sage (*Salvia mellifera* or *S. apiana*, respectively). The site contains decent Coastal California Gnatcatcher habitat that could be improved with restoration.

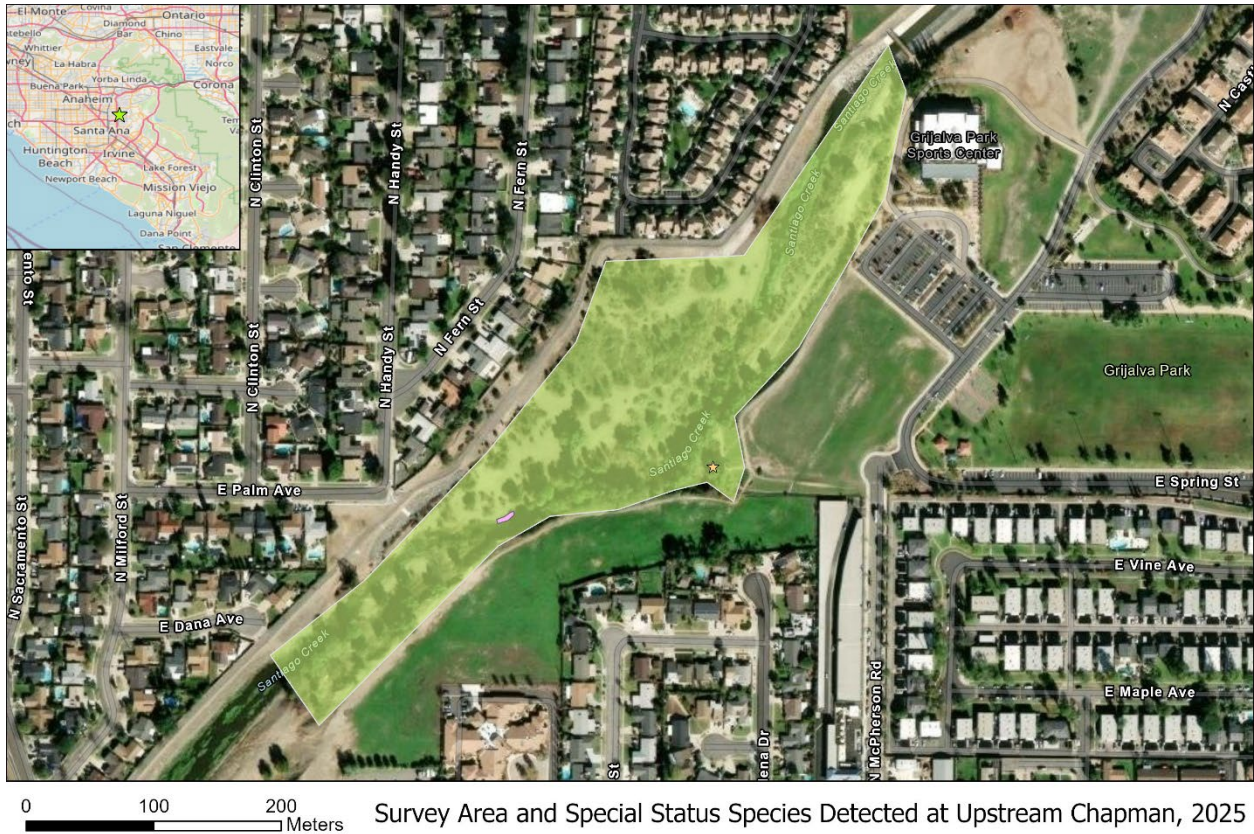
Survey Area and Special Status Species Detected at Upstream Chapman, 2025

The biological assessment took place on May 20, 2025. A large diversity of native vegetation and avian species are present. Vireo were detected on site in 2024 but were not detected in 2025. Other special status species detected on site were Yellow Warbler, and Red-shouldered Hawk (*Buteo lineatus*), a covered species under the County of Orange Central and Coastal Subregion NCCP/HCP. Vegetation coverage estimations for Upstream Chapman are shown in Table 4.

Restoration opportunities include removal of ornamentals, eucalyptus (*Eucalyptus* sp.), Peruvian pepper trees (*Schinus molle*), and castor bean. The riparian habitat would benefit from installation of willow and mulefat pole cuttings, while the drier edges of the site could support additional coastal sage scrub species. Trash is present throughout the habitat, and the site is used recreationally by mountain bikers. There is high potential for establishment of homeless encampments at this location. Installation of fencing to discourage anthropogenic disturbances is recommended if restoration is attempted.

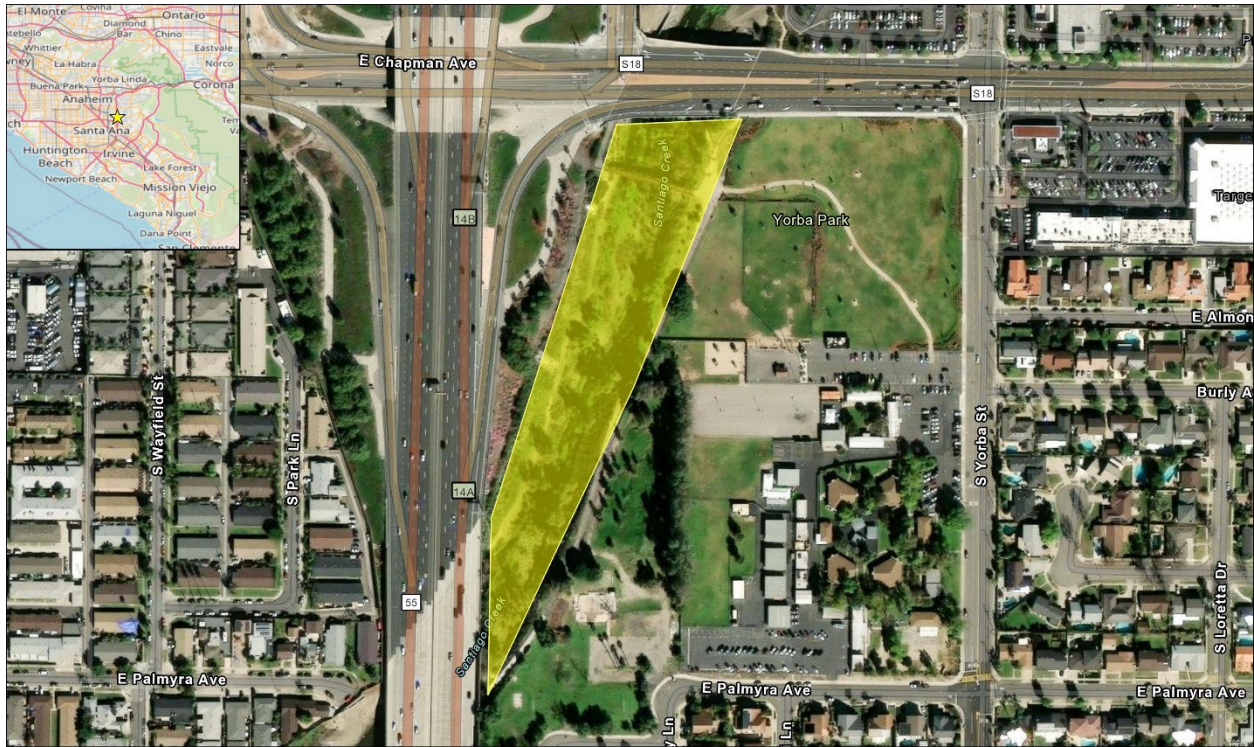
Survey Area and Special Status Species Detected at Chapman to 55, 2025

The biological assessment took place on June 17, 2025. No special status species were detected; however, birds are difficult to hear at this location due to the site’s proximity to SR 55 and related traffic noise. Vegetation coverage estimations for Chapman to 55 are shown in Table 5.

No special status wildlife species were detected.

The site has the potential to be an excellent restoration opportunity and would benefit from the removal of invasive plant species and the addition of willow and mulefat cuttings along with watered hydroseed on the banks.

Though no special status species were found on-site during the biological assessment, a Yellow Warbler was detected on adjacent land and special status species would likely move in a few years after restoration of the riparian habitat.

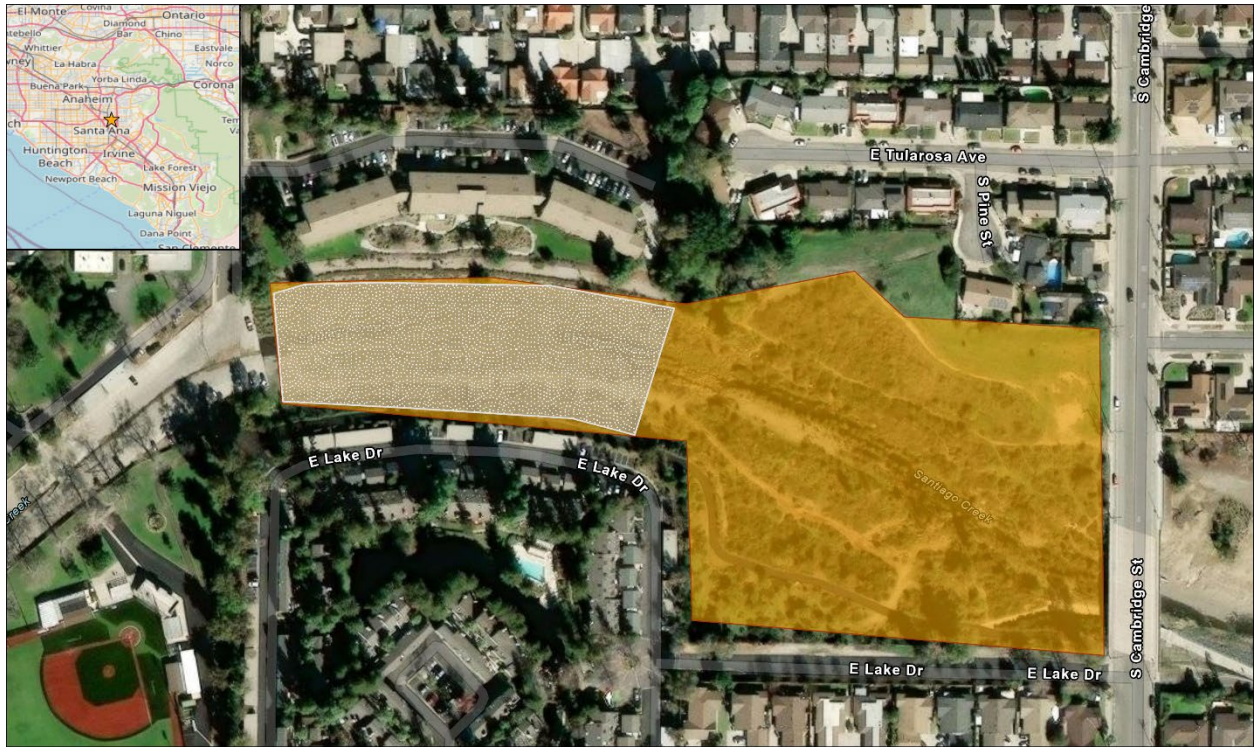
Survey Area and Special Status Species Detected at Cambridge to Hart Park, 2025

The biological assessment took place on June 23, 2025. No special status species were detected. The potential for occurrence of special status species at this location is low unless non-native invasive plant species are removed from the upstream and downstream portions of the creek. Vegetation coverage estimations for Cambridge to Hart Park are shown in Table 6.

No special status wildlife species were detected.

The site presents an excellent restoration opportunity if invasive plant species are removed. This location would benefit from the addition of mulefat and willow pole cuttings as well as hydroseed of coastal sage scrub (CSS) species on the banks, though irrigation would likely be required.

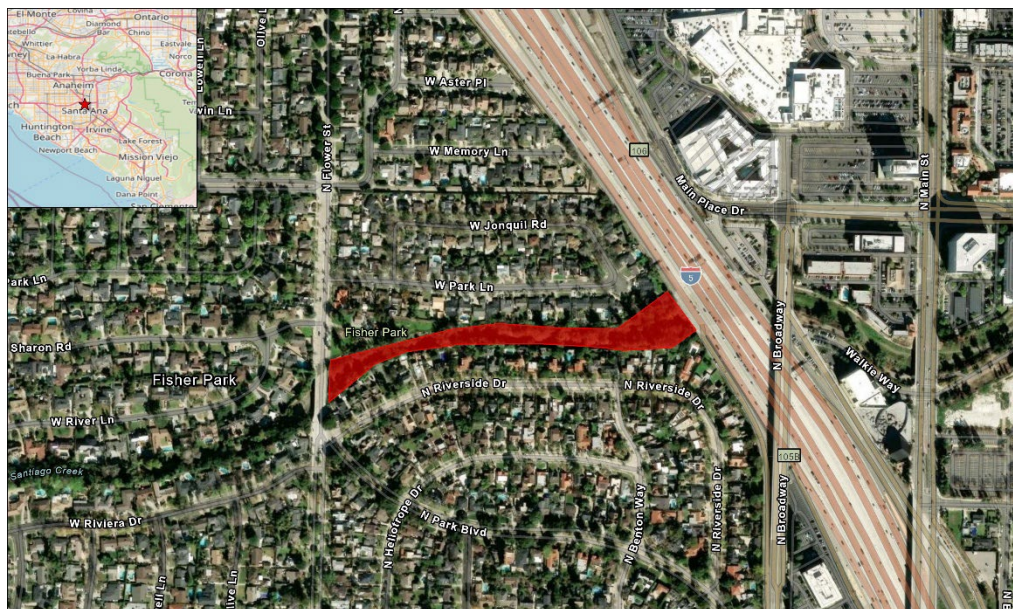
Survey Area and Special Status Species Detected at I-5 to Flower, 2025

The site was inaccessible due to tall fencing surrounding this portion of the creek, which appears to include primarily non-native, ornamental trees. No special status species were detected from the outside borders, though pervasive traffic noise in the area significantly reduces the audible range at which biologists can detect bird songs.

The I-5 to Flower Site was visited but inaccessible due to fencing surrounding the habitat. No special status wildlife species were detected from the perimeter.

None at present.
